# EPA Region IX and California Water Resources Control Board

## NPDES Compliance Evaluation Inspection (CEI) Report

<b>Name and Location of Facility Inspected</b> City of Eureka - Elk River Wastewater Treatment Facility 4301 Hilfkier Lane Eureka, CA 95503		<b>Entry Date</b> 3/15/2013  <b>Entry Time</b> 8:00 AM	<b>Permit Effective Date</b> 7/24/2009
<b>NPDES Permit Number</b> CA0024449	<b>Order Number</b> R1-2009-0033	<input checked="" type="checkbox"/> <b>Major</b>  <input type="checkbox"/> <b>Minor</b>	<b>County</b> Humboldt County  <b>Permit Expiration Date</b> 7/24/2014
<b>Name(s) &amp; Title(s) of On-Site Representative(s)</b> Bruce Gehrke (Utility Operations Manager)	<b>Contact Information</b> Phone: (707) 441-4360 Fax: (707) 441-4366 E-mail: bgehrke@ci.eureka.ca.gov	<b>Notified of Inspection?</b> <input checked="" type="checkbox"/> <b>Yes</b> <input type="checkbox"/> <b>No</b>	
<b>Name, Title &amp; Address of Responsible Official</b> Bruce Young (Public Works Director) 531 K Street Eureka, CA 95501	<b>Contact Information</b> Phone: (707) 441-4203 Fax: (707) 441-4202 E-mail: byoung@ci.eureka.ca.gov	<b>Official Contacted?</b> <input type="checkbox"/> <b>Yes</b> <input checked

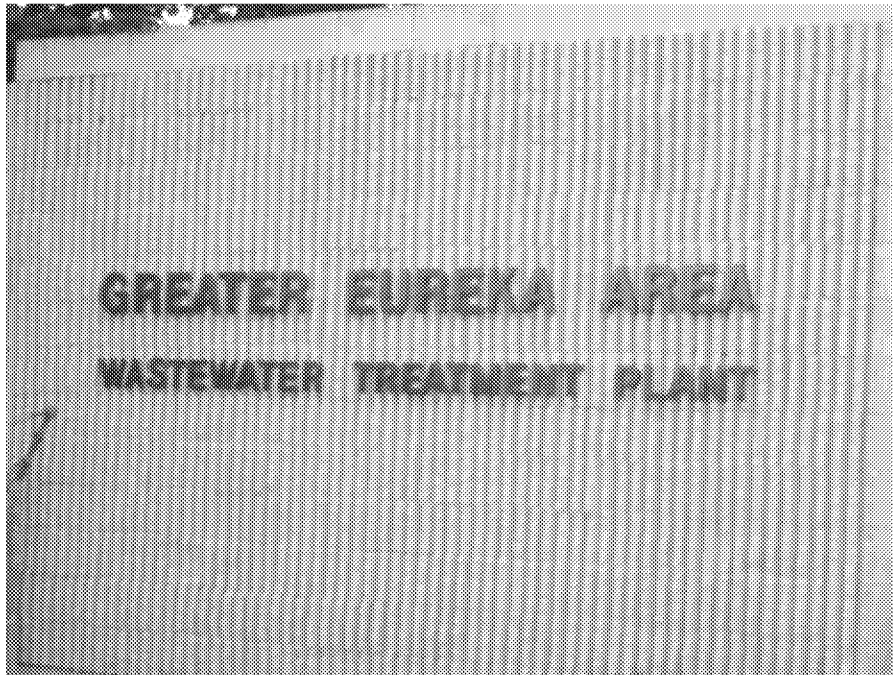
Photo 1: Facility Entrance Sign.
